# Manhole Inspection Summary

Manhole # S15MM1022MH

**Location** Address: **4547 FINNEY AVE**

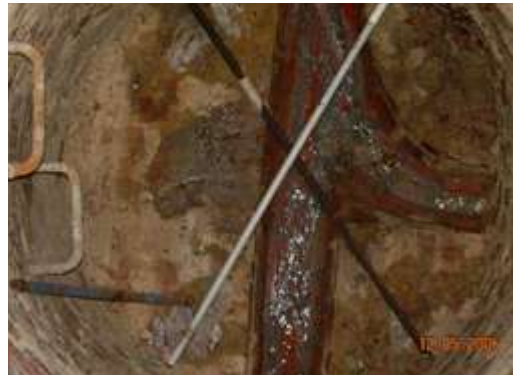
Top View

Barrel infiltration. Evidence of surcharge - Bench debris.

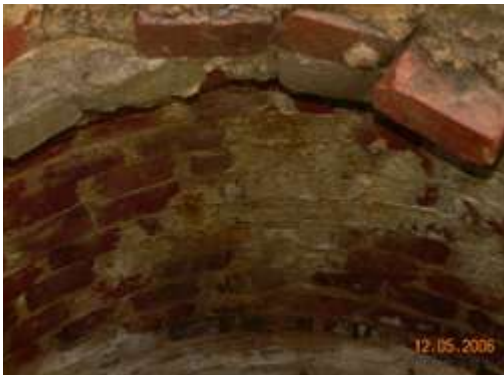
Defect

Condition: ☐ Sound ☐ Cracked ☐ Root Intrusion ☒ **Loose Brick** ☒ **Deteriorated**

Infiltration: ☐ None ☒ **Joint** ☐ Cracks ☒ **Mortar** ☐ Roots ☐ Wall

Adjustment deterioration, loose brick, and infiltration. Corbel infiltration.

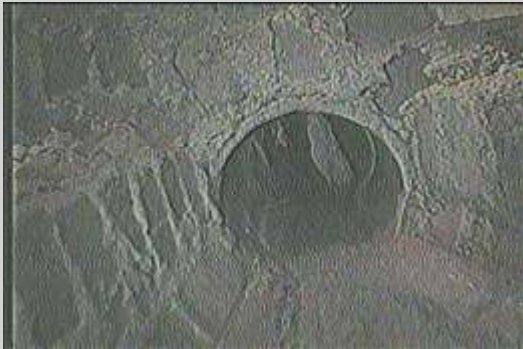
### 8 in. Circular Gravity Sewer Pipe Out @ 12 O'Clock

Infiltration: **None** Pipe Seal Cond: **Cracked**
